# Failure Analysis to 2000 Liter Capacity Light Filter Tank Wall Filter

**Ahmad Zayadi, Cahyono Heri P, Sungkono, Kis Yoga Utomo**

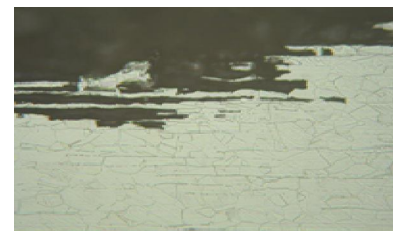
**Figure. 5 :** SX-6 macro and microstructure at 500x micro photo welding location corrosion area

In the SX-6 sample, it was clear that the welding process defects in location (1 and 2) were due to imperfections in the process, namely the presence of a corroded tank wall had not been filled with welding material and was still unclear in the grinding process. Microstructure of SX-6 in the form of austenite with a form of corrosion attack that develops on the surface and this corrosion event is considered serious and

dangerous. Welding defects in SX-6 sample are porosity with a microstructure of welding material in the form of austenite.

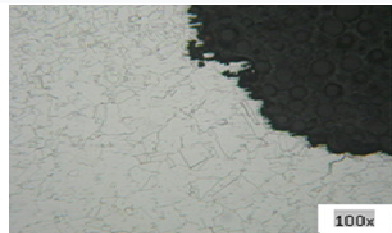
**Figure 6 :** Microstructure of basic material in the form of austenite and experiencing grain boundary cracking (intergranular cracking)

At the location of the SX-10 welding piece, fibers were found in the corroded hole, the fibers were blackish-brown and neatly arranged in the hole in the Heat Affected Zone (HAZ) area and indicated as metal phases corroded due to chemical fluids in the tank the. In the micro etching photo, a corrosion attack occurred in the Heat Affected Zone (HAZ) and Weld Metal (WM) areas. Seen in Figure 6, the microstructure of the welding material is in the form of austenite and has grain boundary cracking (intergranular cracking)

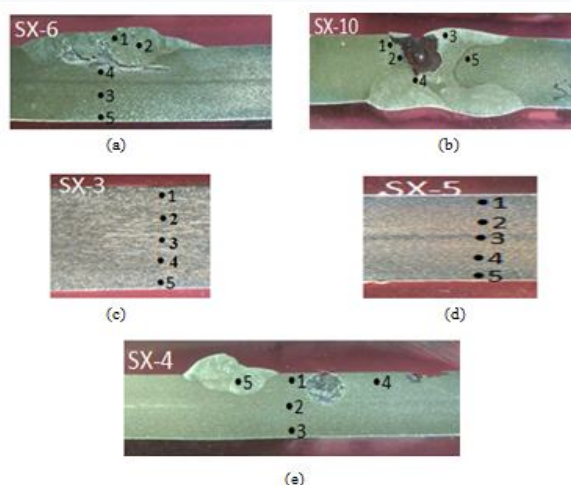
Figure 7. Hardness of test sample

Hardness test results of the soft drink tank filter wall of the five samples have significant differences, especially in the area of the Heat Affected Zone (HAZ) as in the SX-4 test mark 5 (five), the value of hardness is below standard (228 HV) that is 214 HV, in SX -6 test marks 1 and 2, hardness value 181-182 HV and on SX-10 test mark 3 (three), hardness value of 185 HV from the results of all hardness values in the Heat Affected Zone (HAZ) area, it can be seen that the decrease in violence is allegedly due to there is a change in the size of the grains which is getting bigger and

equiaxial in the form of a recrystallization mechanism with higher temperatures and longer welding times. At the location of SX-3 pieces the value of hardness exceeds the standard value of hardness because the area of the parent metal is not touched by the welding process, but at SX-5 pieces the value of hardness at test marks 1, 2 and 3 has decreased violence allegedly due to the cooling process of welding temperature that is too fast. In Table 1 it is known that the average hardness value ranges from 181.4-268.6 HV.
