THE DEMAGE ANALYSIS OF TOYOTA CALYA 1.2 TYPE GM/T 2017 REAR SHOCK ABSORBER

ABSTRACT

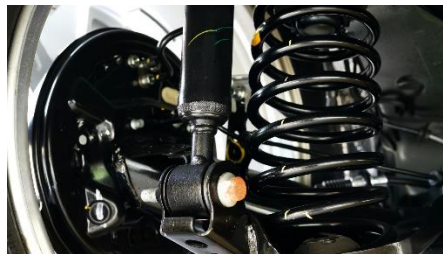
Shock absorber is an important component of a vehicle's suspension system, serves to reduce the oscillating force of the spring. Shock absorbers slow down and reduce the magnitude of the vibration of the movement, by converting the kinetic energy of the suspension movement into heat energy that can be dissipated through the hydraulic fluid (Majanasastra 2013) .

Figure 3. Shock absorber

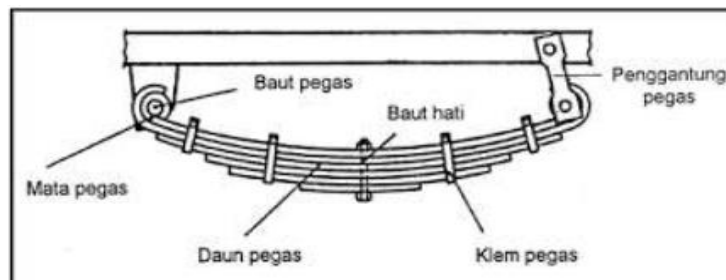
A spring is a flexible machine element that can store energy from applied loads or forces and will return energy equal to the load if the load is removed (Jufri Sialana & Melianus Bunai 2018) .

Figure 4. Spring

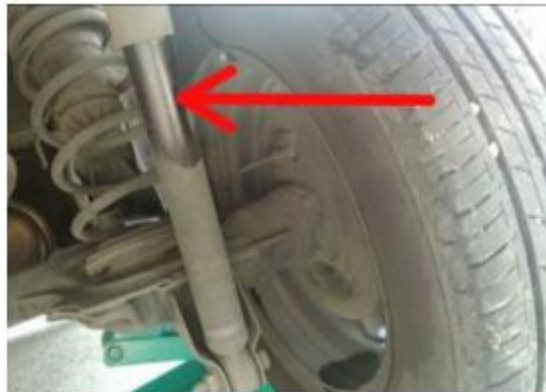
Figure 5. Toyota Calya Rear Absorber Seal Leak.

1. The cause of damage to the genuine Toyota Calya shock absorber is due to deformation of the shock absorber spring due to the spring not being able to reduce the force load that occurs when the vehicle is fully loaded with 1500 kg, so the shock absorber has a stroke that exceeds the allowable standard limit and causes shock damage. faster absorbers.
2. Referring to the results of hardness test data or hardness seal shock absorber. In accordance with the standard seal data table, a good seal condition has a maximum hardness of 85 Shore A , while the actual result of the seal hardness test is 93 Shore A. It can be concluded that material fatigue occurs in the shock absorber seal, causing oil leakage in the rear shock absorber of the Toyota Calya. .

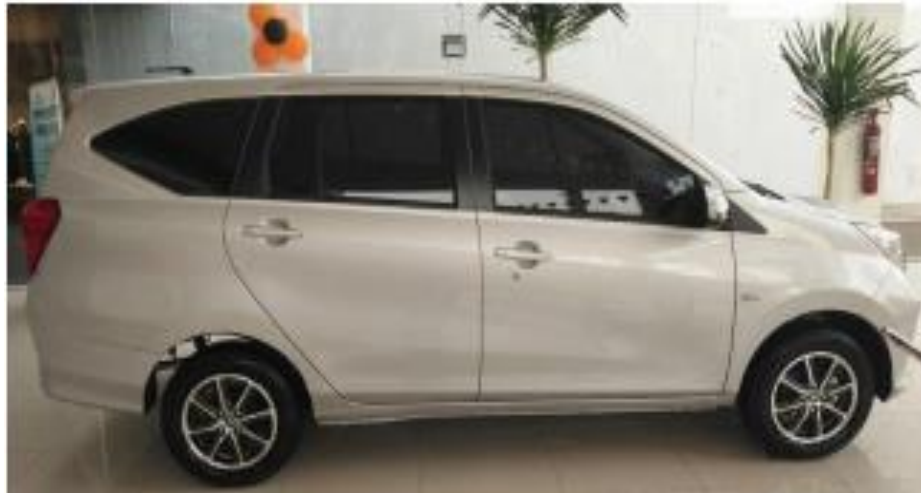
Figure 7. Research Object

DIMENSION OF TOYOTA CALYA G.MT/2017	
L x W x H	4070 mm x 1655 mm x 1600 mm
Wheel axle distance	2525 mm
Number of seats	7 seats
Empty weight	975 kg
Maximum capacity weight	1500 kg
